**Effects on fish communities of Owen Creek bank  
stabilisation and habitat improvement works –  
Engineered Log Jams**

**Final Report**

**June 2015**

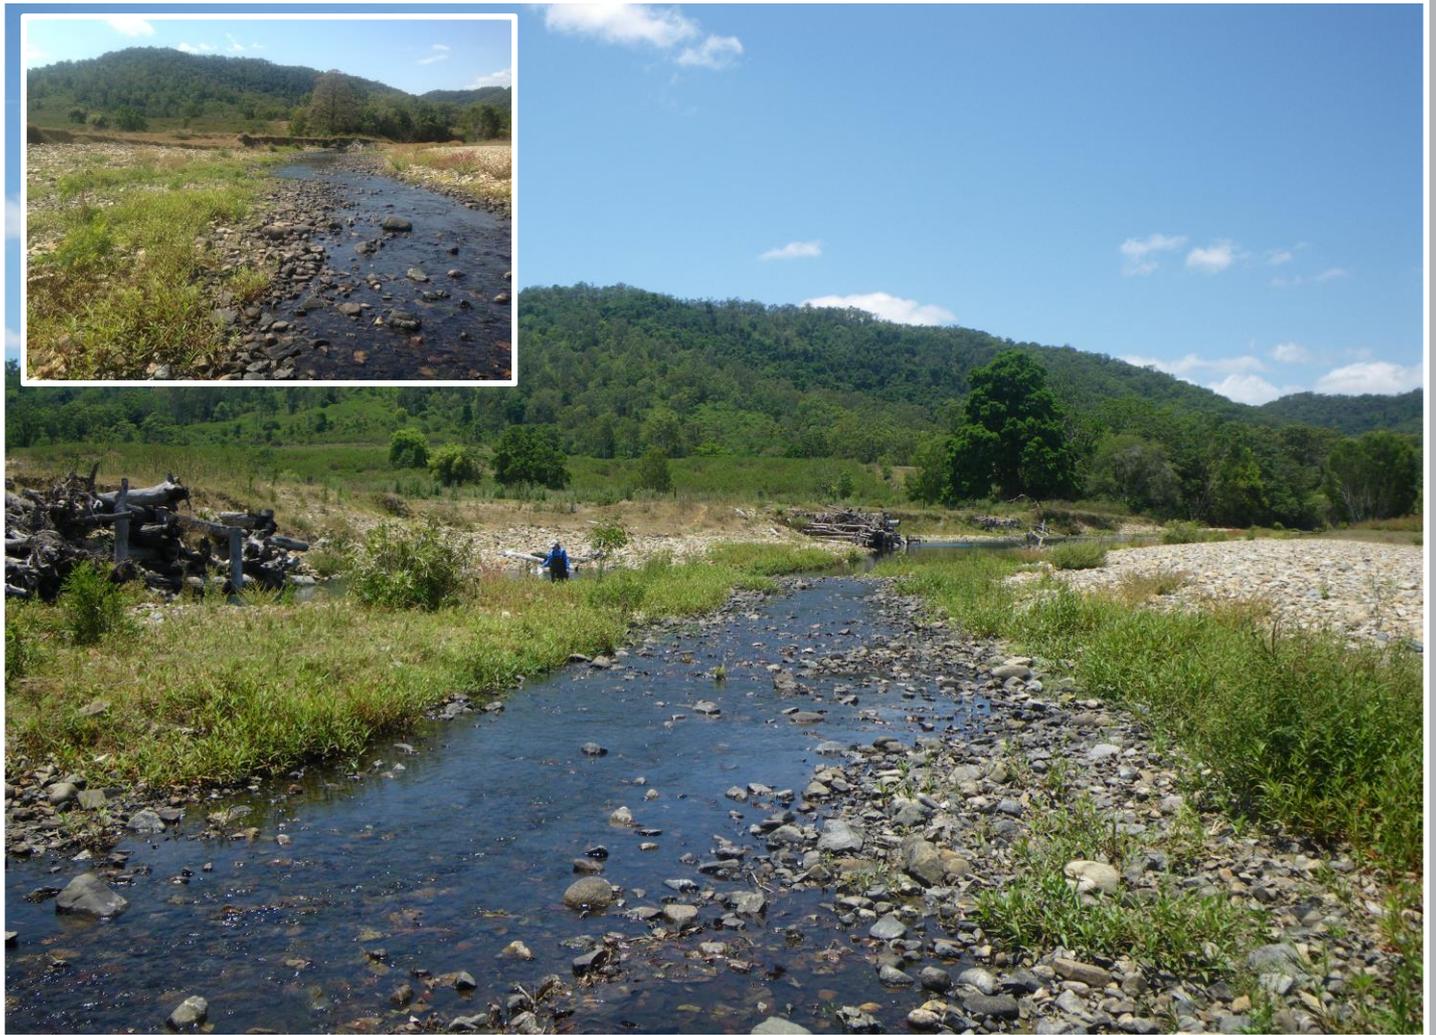
Cover photo: Bank stabilisation and habitat improvement site – post construction 2014, Inset – pre construction 2013, Owens Creek – Pioneer Catchment
