Hilliards Creek Rock Ramp Fishway Monitoring Report

March 2017
Matt Moore

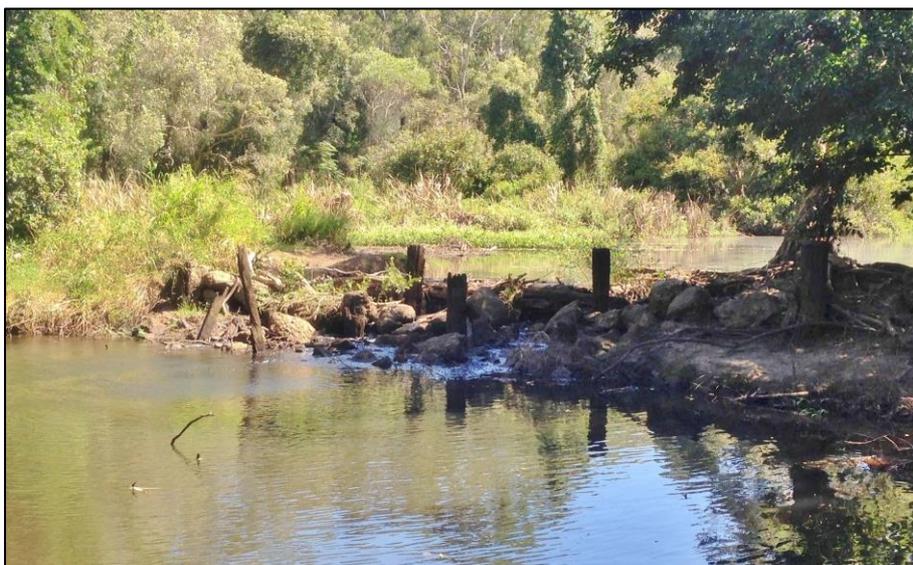
Figure 1. Facing upstream towards Hilliards Creek weir, prior to fishway construction.

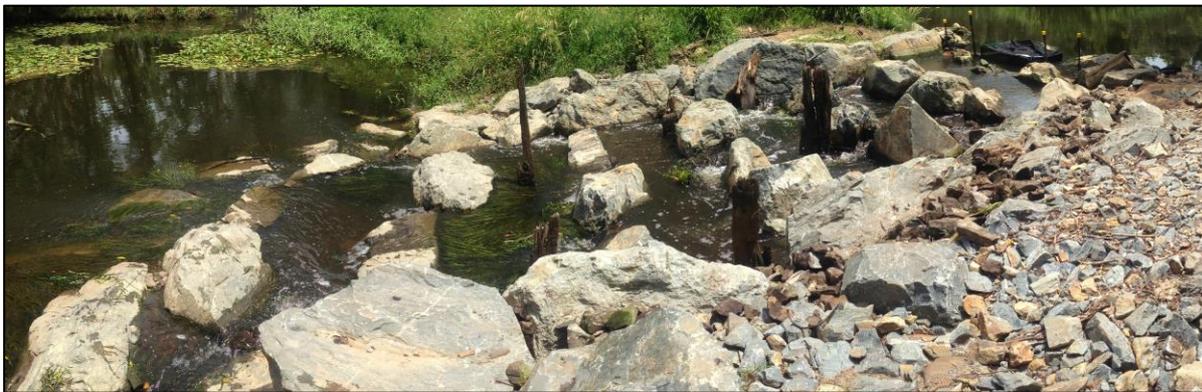
The full width nature-like rock ramp fishway extends 18m in length (Figure 2), and consists of nine ridges and pools (cells). The fishway was designed to operate at an optimal level during low and medium flows with a slope 1V:28.5H. Due to the proximity to estuarine habitats, drops between pools were set at 80mm to cater for weaker swimming juvenile diadromous and small-bodied species within the system. The drops between pools is governed (controlled) by the gap (V-slot) between the ridge rocks that the fish swim through. Fishway pools were approximately 2-3m² and ranged between 0.4 – 0.6 m in depth during low flows. This provided the resting areas and turbulence dissipation that juvenile and small bodied species require to negotiate their way through fishway. Ridges consisted of four slots, with each slot approximately 100-250 mm wide and 200-400 mm high, allowing the fishway to operate over a range of flow conditions. From our sampling, it was found that many small-bodied and juvenile fish were able to negotiate the fishway during the low to medium flow conditions, with the median size of all fish captured 32mm in length (n=819). In high flow conditions, the fishway ‘drowns out’, enabling fish to migrate past.

Figure 2. Showing a side view of the nature like rock ramp fishway (fishway trap located at exit).

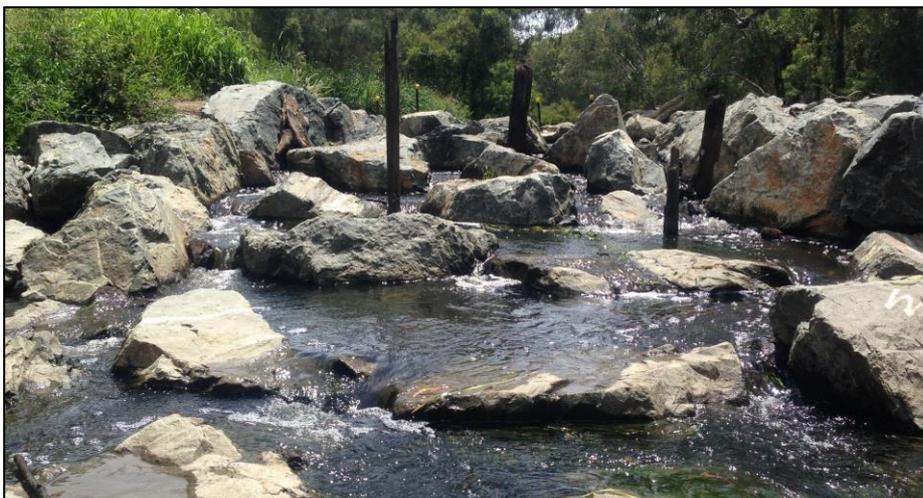
Construction of the fishway involved two 21t excavators fitted with hydraulic rock grabs. The grabs were used to place the 200t of large, igneous rock ranging between 1 – 2.5m³ and weighing up to 5t each, into specific positions to form the ridges and side walls of the rock ramp. Each ridge rock was methodically placed to form V-slots (the gap between the ridge rocks that the fish swim through), with the bottom of the ‘V’ set at the exact control height for each ridge. This was undertaken while ensuring each ridge rock was sufficiently embedded into the stream bed and each ridge rock maintained at least a 400mm distance from the stream bed to the control (V), and a further 200-400mm clearance above the control (Figure 3).

Figure 3. Facing upstream at the fishway; showing pools, ridges, and ‘V’-slots (gaps between ridge rocks that fish swim through which also control the height of each pool).

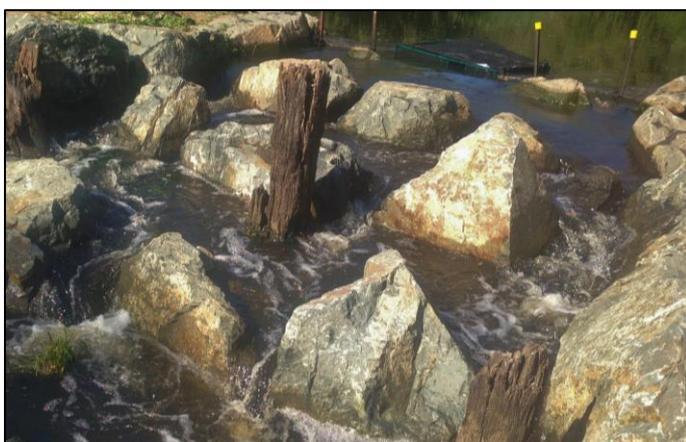
Fishway trap monitoring was carried out over five days during low flow conditions between the 15th -19th of December, 2016. Fishway trap monitoring was undertaken to evaluate the success of the fishway at facilitating fish passage past the barrier for all size classes of fish. Monitoring was undertaken by placing a purpose built fishway trap and wing-wall configuration at the upstream exit of the fishway (Figure 4), intended to capture fish once they had successfully ascended the fishway. A small number (n=10) of endemic juvenile (~40 mm) Australian bass were PIT tagged and released at the bottom of the fishway. This was undertaken to provide useful data on the ability of this recreationally important species to ascend the fishway in-case 'wild' specimens were not migrating at the time of sampling, or could not access the fishway due to barriers downstream, i.e. Fellmonger Park causeway. Monitoring results demonstrate that the fishway is operating successfully, with fish as small as 15mm moving through the fishway into upstream habitats.

Figure 4. Showing fishway trap and wing wall configuration located at the fishway exit (foreground).

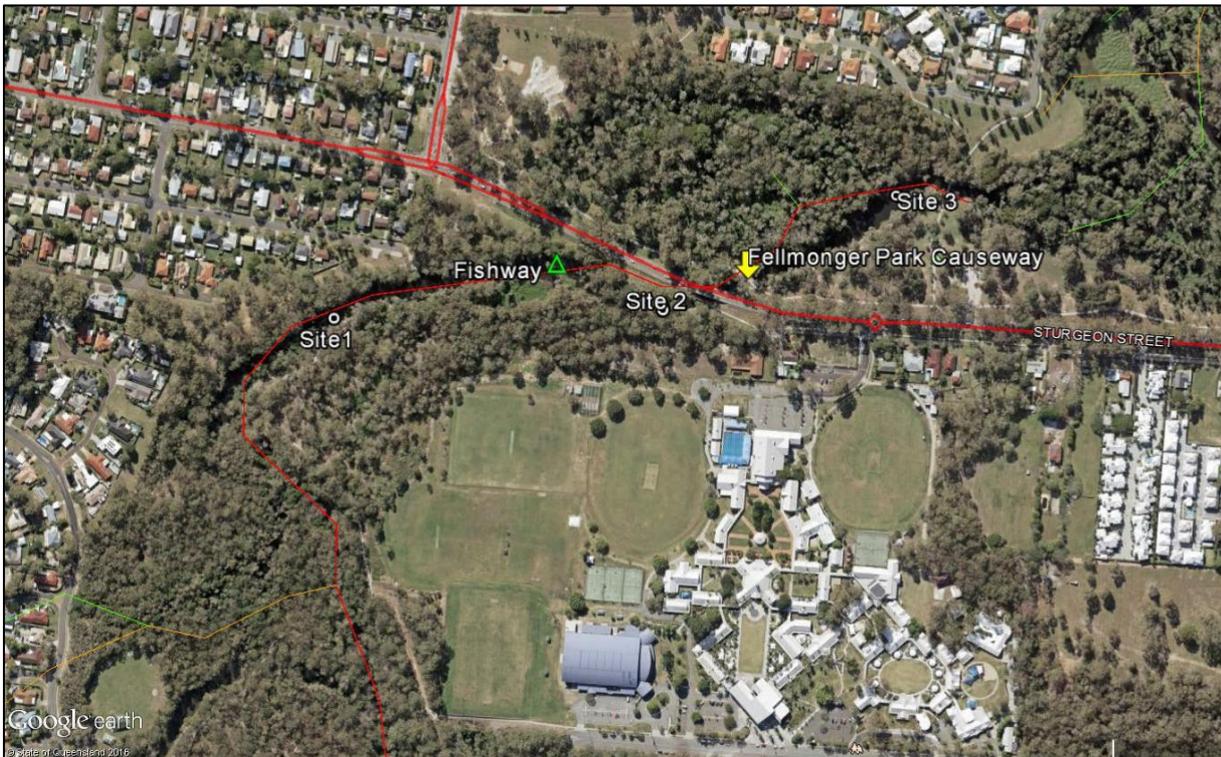
Figure 6. Inset map showing fish community monitoring sites, fishway and Fellmonger Park Causeway barrier.

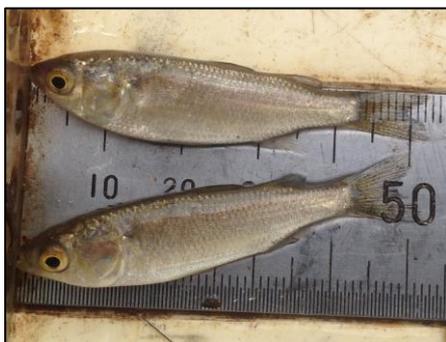
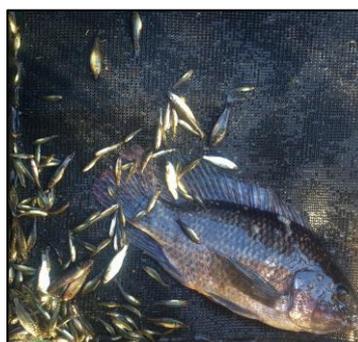
Figure 7. Typical size of juvenile sea mullet captured migrating through the fishway (left), and typical trap haul consisting predominantly of *Hypseleotris* sp., empire gudgeon, fly-specked hardyhead, sea mullet and one large adult (female) tilapia (right).

In total, 809 individual fish representing 11 species (eight native and three introduced) were recorded (Table 1). Fish were monitored successfully ascending through the fishway at a catch rate of 177.66 fish/day. Significantly, very small juvenile diadromous fish species (Figure 7) were able to migrate through the fishway, including a 19mm empire gudgeon, 35 mm Australian bass, 38 mm striped gudgeon, 38 mm sea mullet and a 60 mm long-finned eel. Overall, the median size of all fish captured was just 32mm. The smallest size potamodromous (wholly freshwater) species included 15 mm exotic *Gambusia*, 20 mm *Hypseleotris* sp. and a 20 mm fly-specked hardyhead. The small size of fish species able to successfully ascend through the fishway is significant (and used as an indicator of fishway success), as they possess weaker swimming abilities when compared to larger bodied species. The largest fish species recorded migrating through the fishway included an 800 mm long-finned eel and a 329mm tilapia (Figure 7).

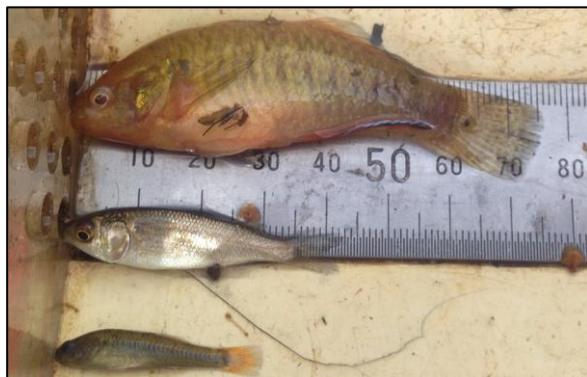
Figure 8. Showing adult empire gudgeon (top), juvenile sea mullet (middle) and adult *Hypseleotris klunzingeri* (bottom).

Hypseleotris species (unable to be positively identified in the field- specimens sent to the Qld Museum for correct identification which revealed the presence of both *H. klunzingeri* (Figure 8) and *H. species 1*) were the most abundant species representing 43.5% of the catch at an average of 77.4 fish/day moving through the fishway. Fly-specked hardyhead were the second most abundant species, representing 30.7% of the catch at a capture rate of 30.8 fish/day, followed by the diadromous empire gudgeon (Figure 8) and sea mullet (Figure 8) representing 10.2% and 8.8% of the catch at a catch rate of 18.2 and 15.6 fish/day respectively.

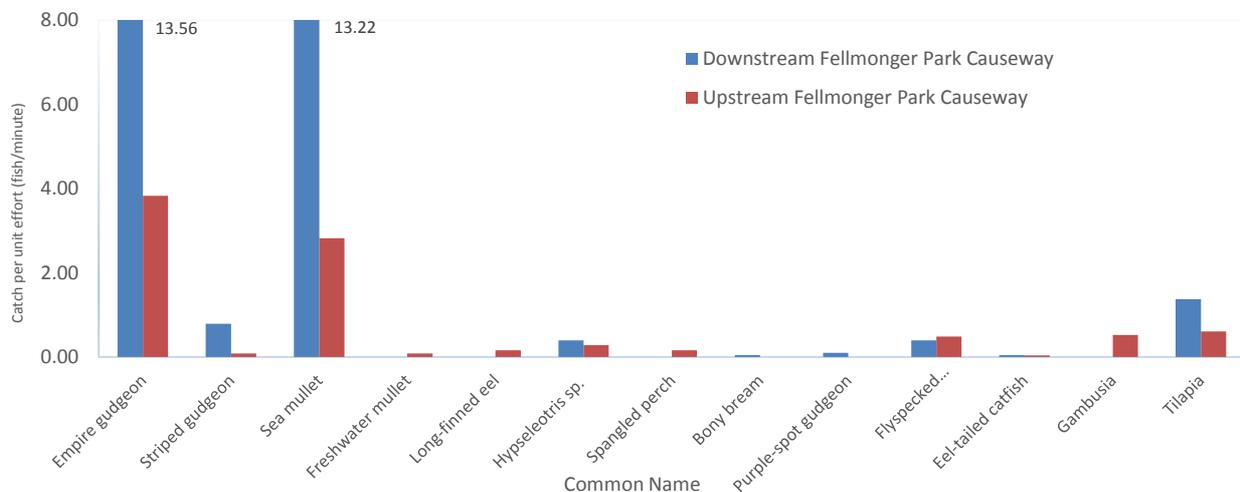
Diadromous fish species; empire gudgeon, sea mullet and striped gudgeon were captured at considerably higher catch rates downstream of the FP causeway when compared to upstream (Figure 9). Four fish species; freshwater mullet, long-finned eel, spangled perch and *Gambusia* were only recorded from the upstream site, whilst bony bream and purple-spotted gudgeon were only recorded at the downstream site.

Figure 9. Showing comparison fish catch rates between upstream and downstream FP causeway barrier sites.

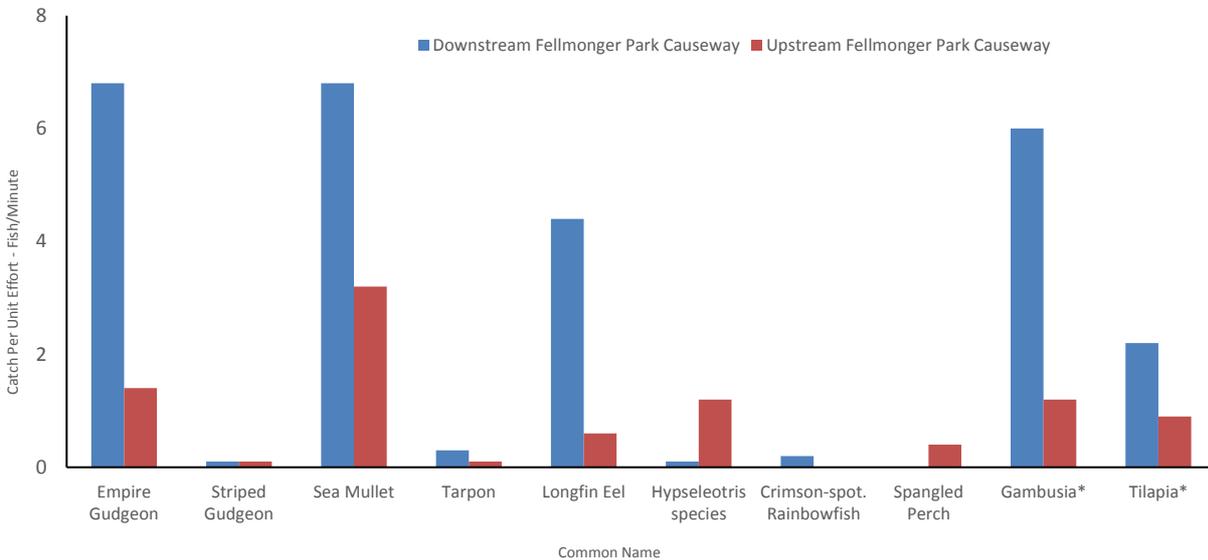
Diadromous species; empire gudgeon, sea mullet, long-finned eel and tarpon were all recorded at higher catch rates (fish/min) downstream of the FP causeway (Figure 10). Pest fish species *Gambusia* and tilapia were also recorded at a higher catch rate downstream of FP. Potamodromous fish species; *Hypseleotris* sp. and spangled perch were recorded at higher catch rates upstream of FP.

Figure 10. Showing comparison fish catch rates between upstream and downstream FP causeway sites.

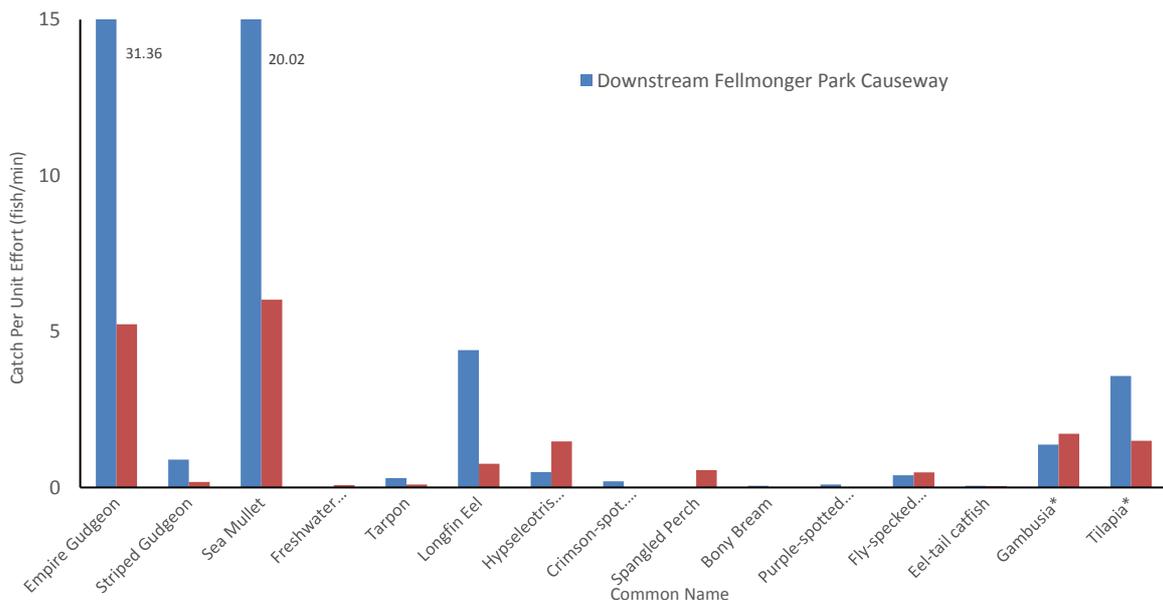
Diadromous species; empire gudgeon, sea mullet, striped gudgeon, tarpon and long-finned eel were recorded at higher catch rates downstream of the FP causeway. Potamodromous fish; *Hypseleotris* sp., spangled perch and fly-specked hardyhead were recorded at higher catch rates upstream of the FP causeway (Figure 8).

Figure 11. Showing comparison fish species catch rates between upstream and downstream FP causeway barrier sites during post fishway construction fish community monitoring.

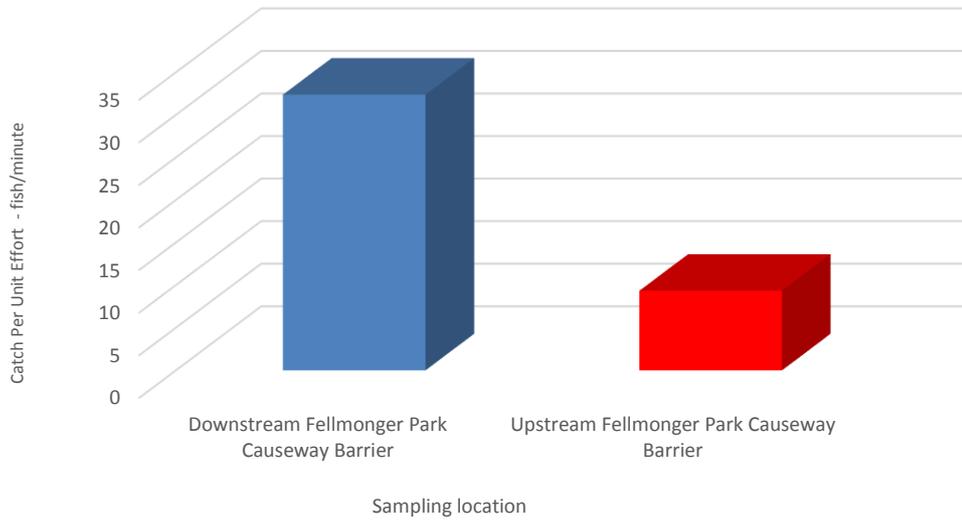
Total catch rates for all fish species pooled were over three times higher (Figure 12) downstream of the FP causeway (32.37 fish/min) compared to upstream of FP (9.33 fish/min).

Figure 12. Showing pooled pre and post fishway monitoring data for fish species at downstream and upstream FP causeway sites.

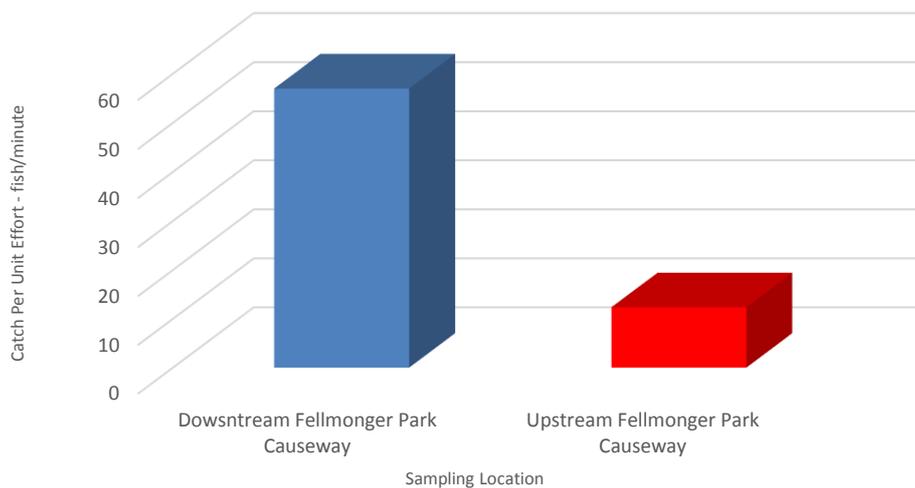
Total catch rates pooled for diadromous fish species only were over four times higher (Figure 13) downstream of the FP causeway (56.97 fish/min) compared to upstream of FP (12.37 fish/min)

Figure 13. Showing pooled pre and post fishway monitoring data for diadromous fish species at downstream and upstream FP causeway sites.
