Blackrock Creek Fishway –Monitoring Report

August 2017
Trent Power & Jack McCann

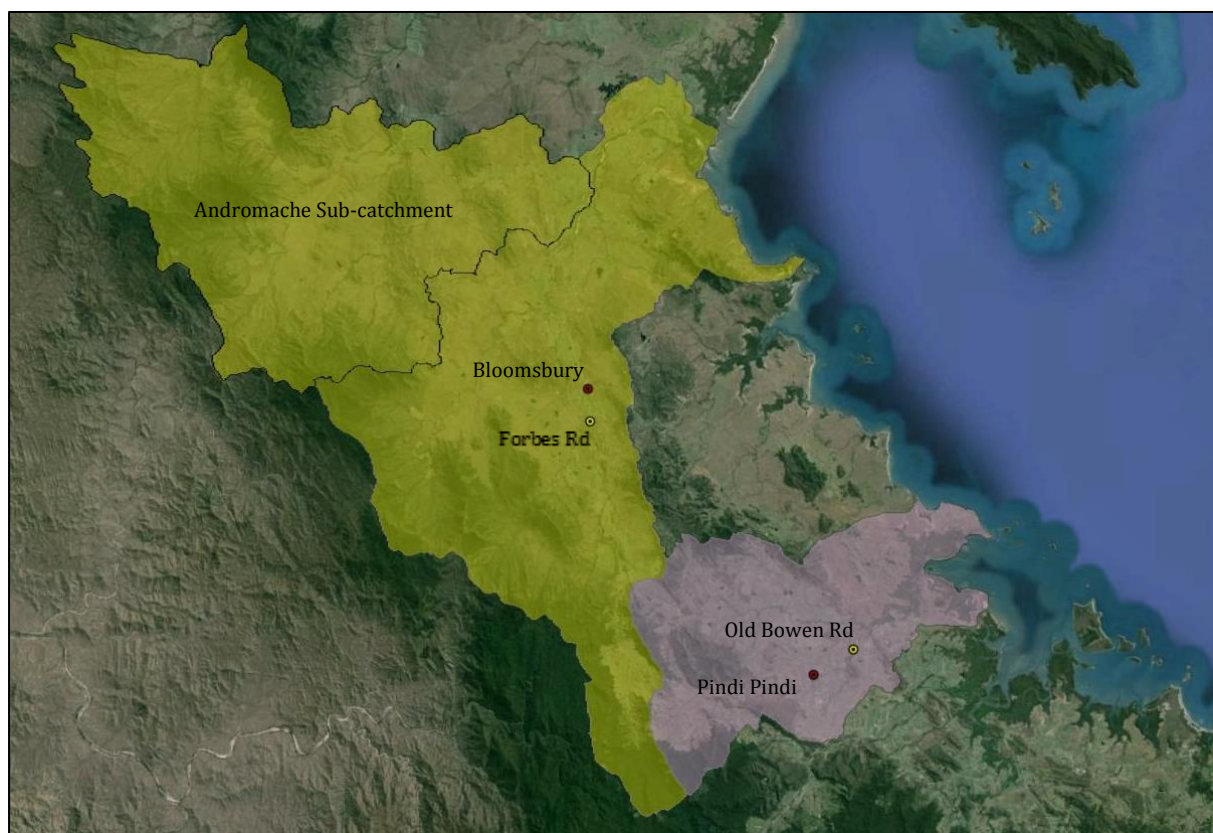
Figure 1. Yellow - O'Connell River Catchment including the township of Bloomsbury, location of Forbes Road fishway and northern Andromache sub-catchment. Pink – Blackrock Creek Catchment including township of Pindi Pindi and locations of Old Bowen Road causeway.

The headwaters of Blackrock Creek are adjacent to Eungella National Park draining eastwards past the township of Pindi Pindi then turning north east, entering the sea at St Helens Bay (Figure 1). The upper reaches are in poor condition with grazing adjacent to the creek system with limited riparian shading and zones. As the creek moves into the floodplain, extensive cropping surrounds the creek system with moderate riparian zones. The lower reaches and estuarine areas have moderate riparian and marine plant zones with extensive grazing to the north of the estuarine habitat. Typical habitat upstream and downstream of Old Bowen Road are provided in Figure 2. Blackrock Creek typically experiences increased flow during the wet season and low flows during the dry season. In dry years Blackrock Creek can cease to flow forming a series of refuge pools along the stream network.

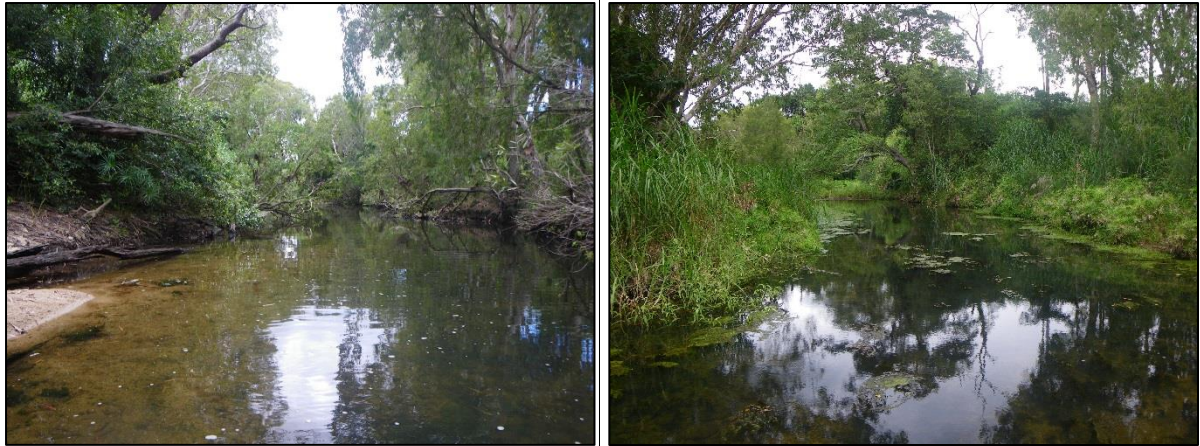
Figure 2. Instream habitat upstream (Right) and downstream (left) of Old Bowen Road, Blackrock Creek.

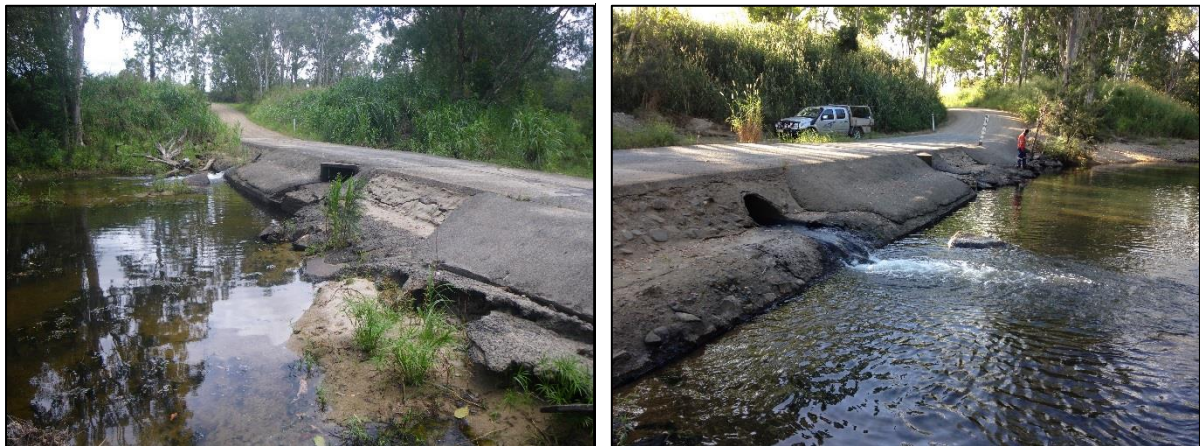
The causeway was of concrete and bitumen construction, consisting of a deck with approach and exit ramps as well as concrete scour protection aprons both upstream and downstream of the deck. The structure is approximately 42 m in length and 6 m wide. Incorporated into the causeway are three separate culvert barrels. Each barrel was set at different locations and elevations. Two of the barrels were functioning, while the third was entirely blocked with sediment and had become obsolete. The two functioning culverts included a 1200 x 500 mm RCBC and a 600 mm pipe culvert. Photos of the causeway prior to the fishway construction are provided in (Figure 3).

Figure 3. Views of Old Bowen Rd causeway prior to the fishway installation (left – looking south, right – looking north).

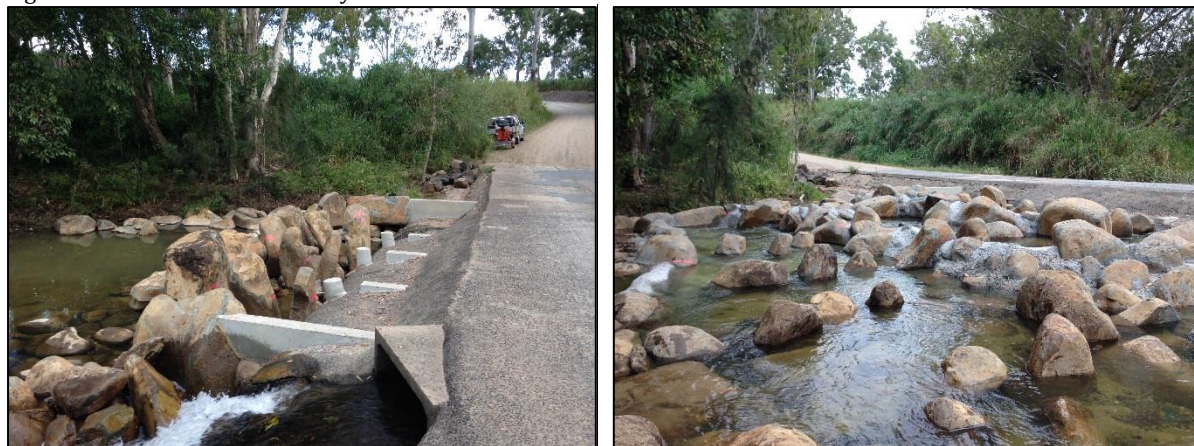
Figure 5. Blackrock Creek fishway during construction (left) and shortly after completion (right).
