NEILLY GROUP

REEF TRUST IV COLLINSDALE STATION
FITZROY RIVER CHANNEL AVULSION
REMEDICATION DETAIL DESIGN

APRIL 2019

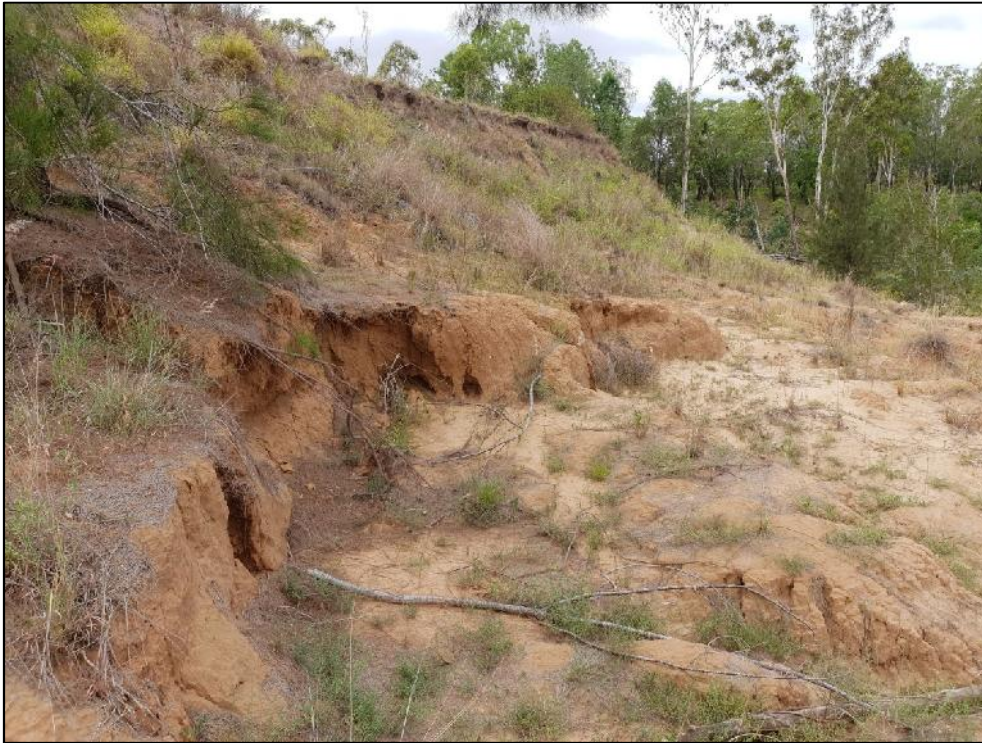
Figure 1: Photo looking approximately south along the eroded face of the avulsed area (Bank is approximately 5 m tall).

-) The avulsed area was typically devoid of topsoil and generally comprised medium dense silty sand to approximately 0.3 m depth in some instances, underlain by dense or hard orange-brown silty clayey sand or silty sandy clay. Premature refusal was caused by very dense/hard silty clayey sand/silty sandy clay at 0.9 m depth in Pit 1. A representation of the avulsed area is presented in Figure 1.

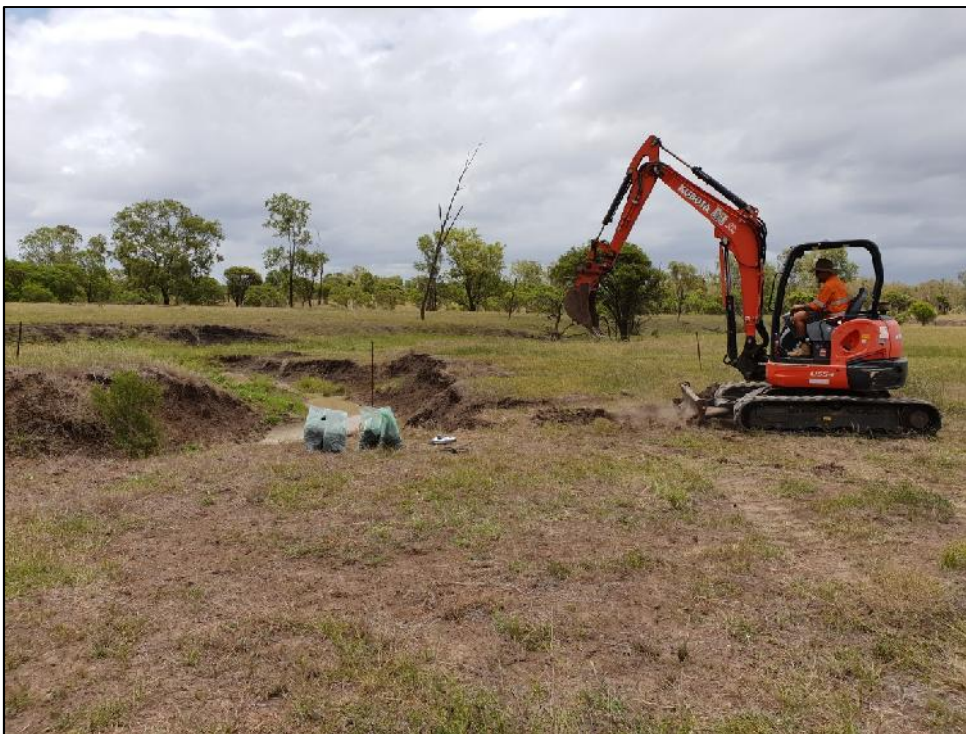
Figure 2: Photo looking approximately North to incised dam wall (left), with excavator backfilling Test Pit 7.

- Moderate to heavy grazing pressure from cattle evident.
 - Incision of eastern edge of dam wall was evident (refer Figure 2).
