NEILLY GROUP

CATCHMENT SOLUTIONS

BANNOCKBURN STATION REEF TRUST IV GULLY REPAIR DESIGN ADDENDUM

MAY 2020

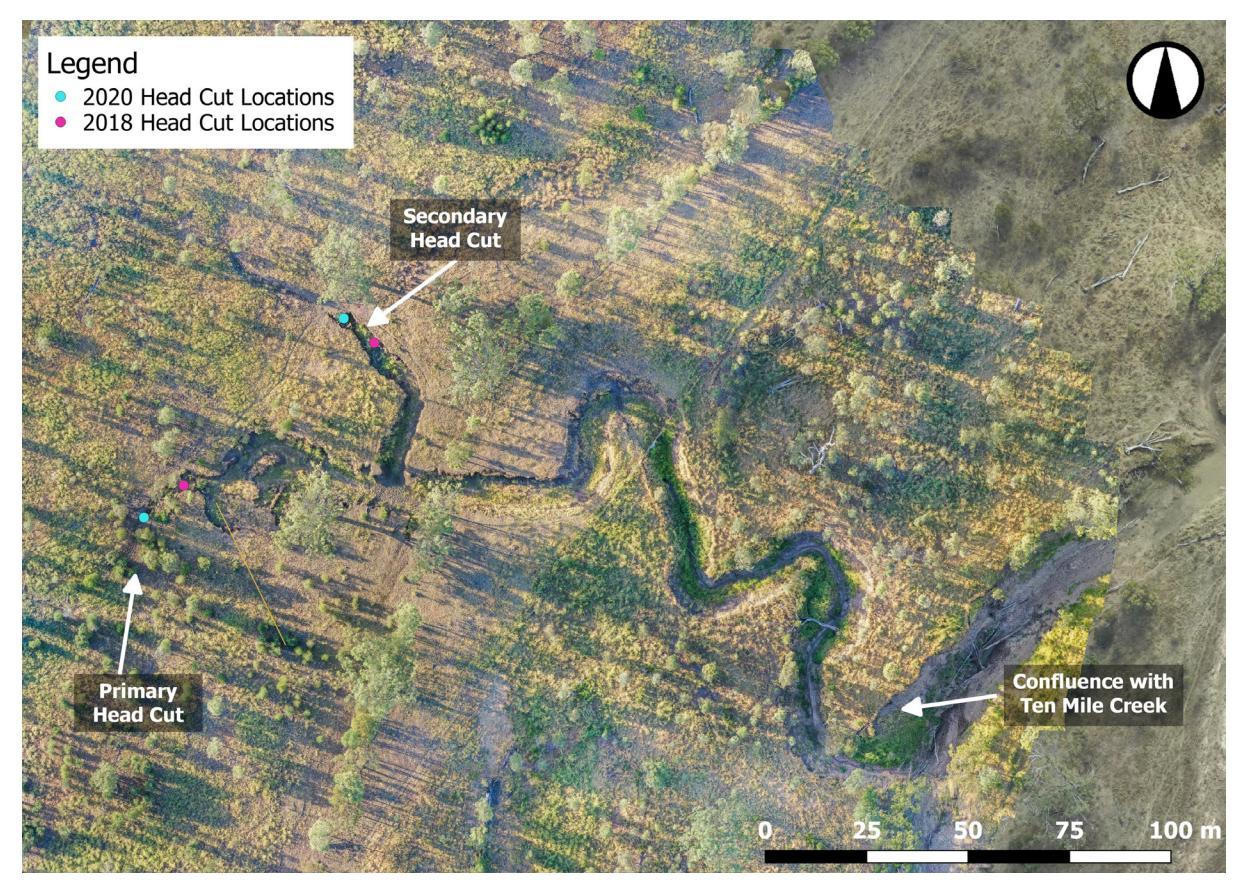
Figure 1. Site overview

Both gullies have migrated further upstream over the period from 2018 to 2020. The primary head cut of the gully erosion inspected for remediation is now located approximately 293m upstream of Ten Mile Creek. Figure 1 provides an overview of the site layout with a comparison of the gully head cut locations from 2018 to 2020.

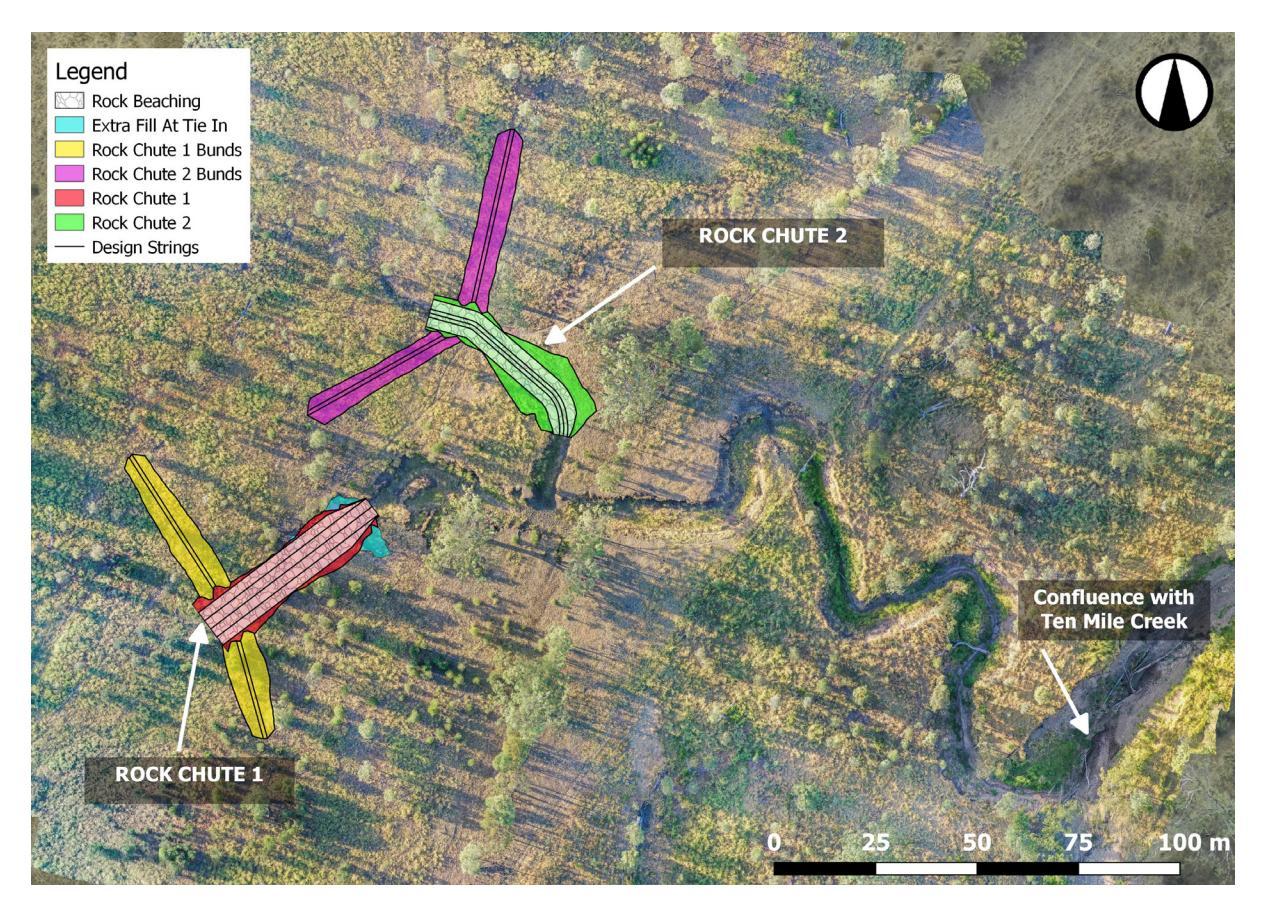
Figure 2. Overview of proposed design

Rock chutes have been designed to the 5% AEP peak flow rate, as derived by the hydrologic modelling previously undertaken and reported in *Bannockburn Station Reef Trust IV Gully Repair Design* (Neilly Group Engineering, 2018). An overview of the rock chute drop structures and their accompanying overland flow bunds is shown in Figure 2 below, with a summary of the rock chute drop structure design details shown in Table 1. Full details are contained in the drawings as Attachment A and in the schedule of quantities in Section 4. Details for constructing the works are included in *Technical Specification: Bannockburn Station Reef Trust IV Gully Repair Design* (Neilly Group Engineering, 2020).
